Dealing with legacy pin 1 problems

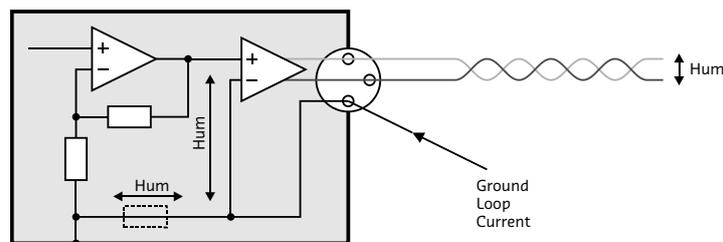
Hum is often presented as something that only affects inputs. That’s a flawed assumption. Here’s a drawing showing an *output* which picks up hum injected through pin 1.

The loop current flows through the internal reference node (“audio ground”) and causes a voltage to develop in the wiring resistance of this node. Hum is introduced everywhere in the circuit.

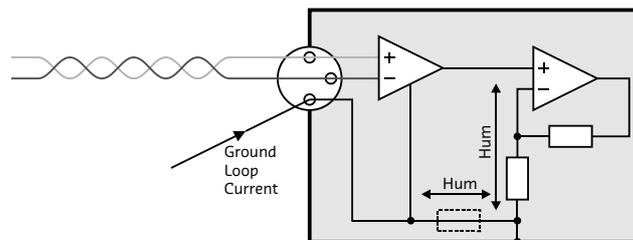
For completeness, here’s the same drawing for an input.

The root cause is the fact that an unthinkingly connected pin 1 functions as an unplanned input that gives direct access to an internal wire that nobody has any business with. This is completely unnecessary and counterproductive.

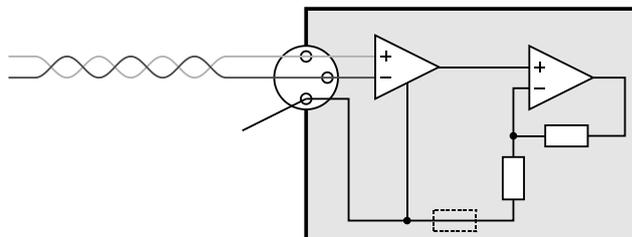
One can think of many places to cut the current flow. For reasons the author doesn't understand, everyone at some point seemed to think the connection between the audio circuit and the chassis was the most logical one. That's remarkable. A psychologist should look at it.

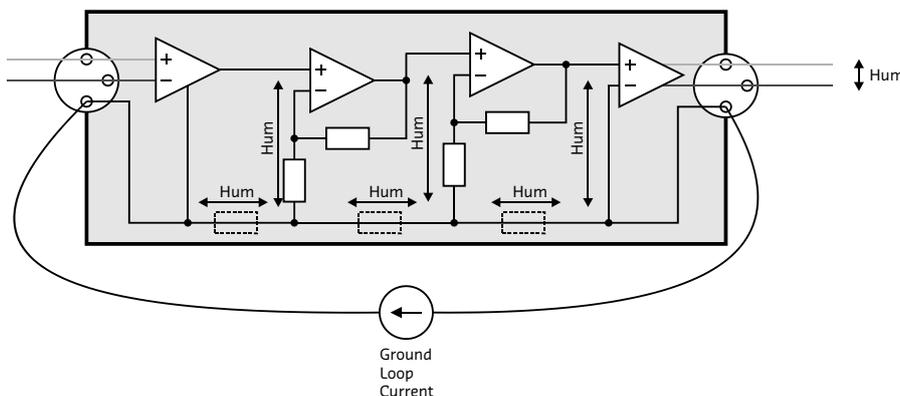
There are several reasons why this is flawed. First the *glaringly* obvious one: the chassis isn't always part of the loop, and disconnecting it will have no effect. As soon as you connect a second XLR, you're once again running your ground loop current all the way through your audio circuit.

Didn't help, did it? All that time invested trying to convince suppliers to make special parts with insulated screw holes and it just doesn't bloody work. **Lifting the ground is no solution.** It only helps to some degree when you have *exactly* one audio connector (an input or an output). But how many products can we think of with only one output and no input or vice versa? As soon as a second XLR turns up, that's the end of it. There is not a single documented case of an EQ or a compressor in which a ground lift switch has ever solved a hum problem. Didn't stop anyone from adding ground lift switches though and feeling smug about it.

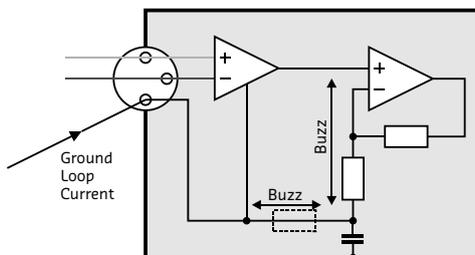
The second reason is that for various EMC related reasons the circuit still ends up capacitively coupled with the chassis. Depending on the case, the capacitances range from nanofarads to microfarads.

Now, a 500nF capacitor may be a high impedance at 50Hz, at 4kHz it's not. Hum with the fundamental and lower harmonics removed is called "buzz". It's hardly an improvement.

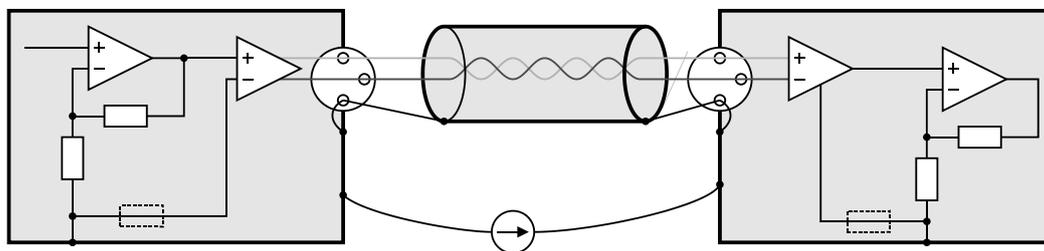
Ground loops are a fact of life. There are many situations in which they can't be eliminated. So pin 1 should be recruited to safely conduct loop currents *around* the audio circuit instead of *through* it.

This astoundingly simple solution has been widely publicised and is enshrined in a standard called AES48. It has been wildly successful. It has been almost universally adopted and pin 1 problems are largely over.

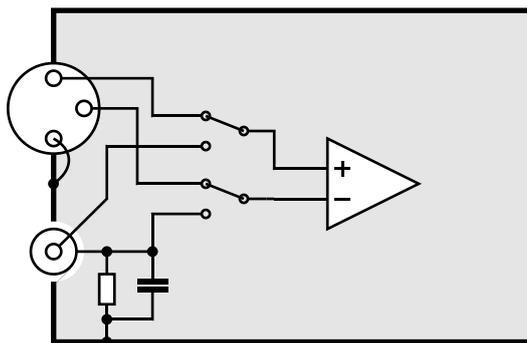
When you're a manufacturer of semi-professional gear and you need to fit an RCA input on a grounded product, you do the same thing:

Essentially a differential input is a floating input. Nothing more, nothing less. The only reason why one should consider including an RC combination is to keep the signal within the common mode range of the input circuit (remember that the source may be floating) and to keep RFI that's been picked up by the RCA cable out of the box.
